Your Inspection Report

SAMPLE REPORT

Friday, October 28, 2016

Terra Property Inspections - Johnny Carrillo

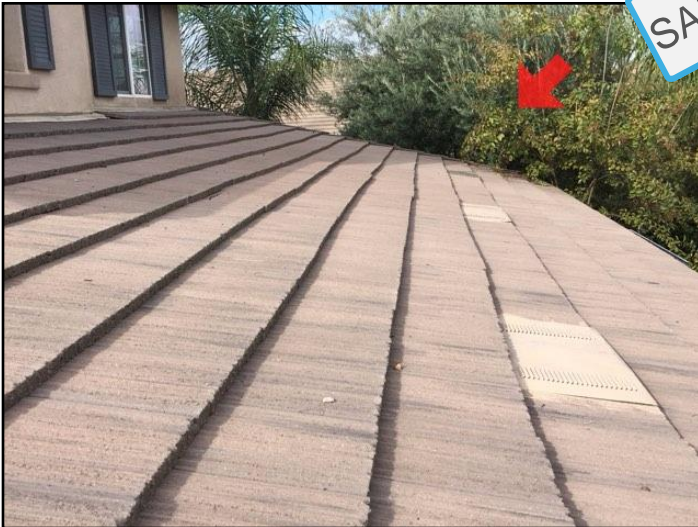
Condition: • The surface shows typical conditions related to the age of the roof. Recommend monitoring for any developments.

Note: Recommend trimming trees in contact with the roof.

View of tiles - Need to trim trees

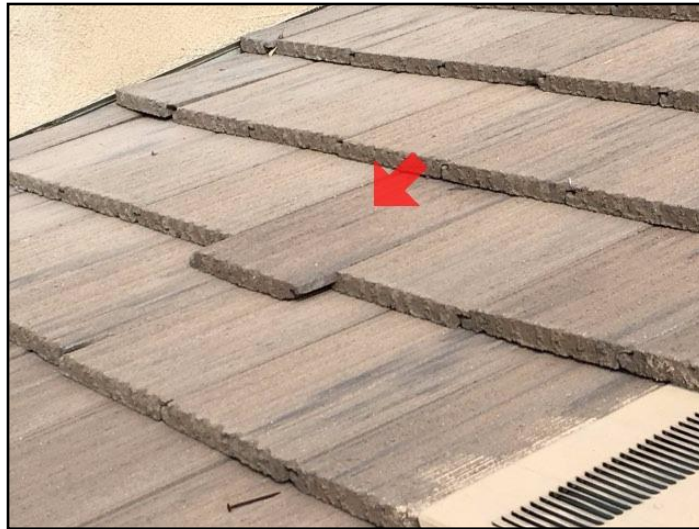
Condition: • [Missing, loose or broken pieces](#)

Implication(s): Damage or physical injury due to falling materials | Chance of water damage to contents, finishes and/or structure

Location: Lower rear slope

Loose tile

Task: Re-position and secure tile

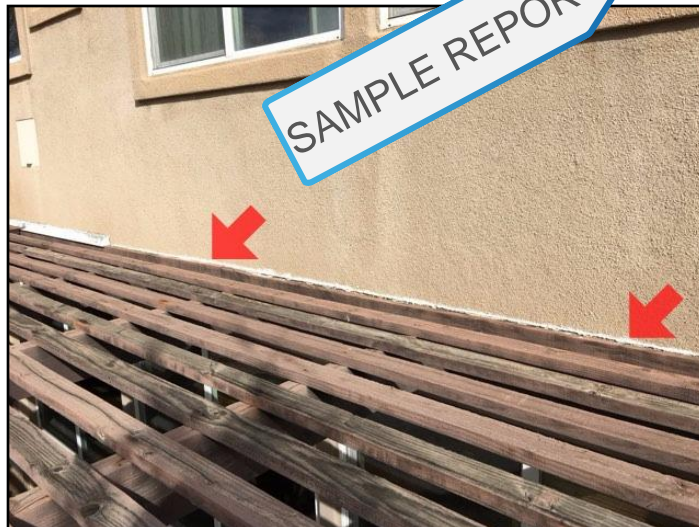
Condition: • Missing wall flashing

Implication(s): Trapped water

Location: Rear trellis

Missing flashing

Task: Install flashing

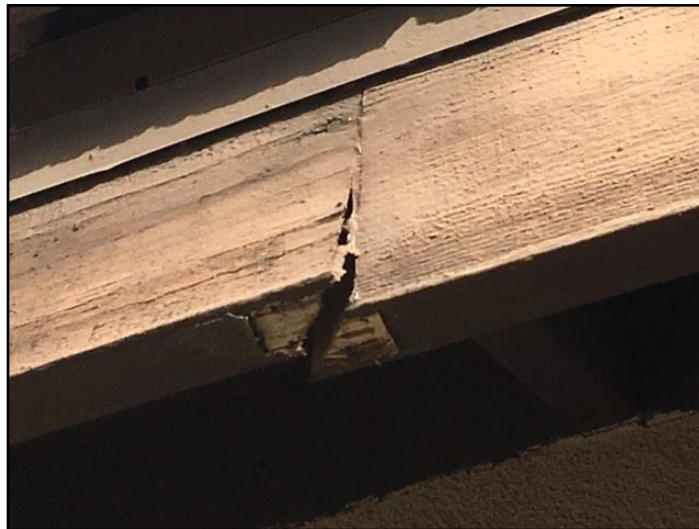
Condition: • Fascia board separation
Implication(s): Complete separation
Location: Rear of home, lower fascia board
Task: Repair to re-attach

Separation

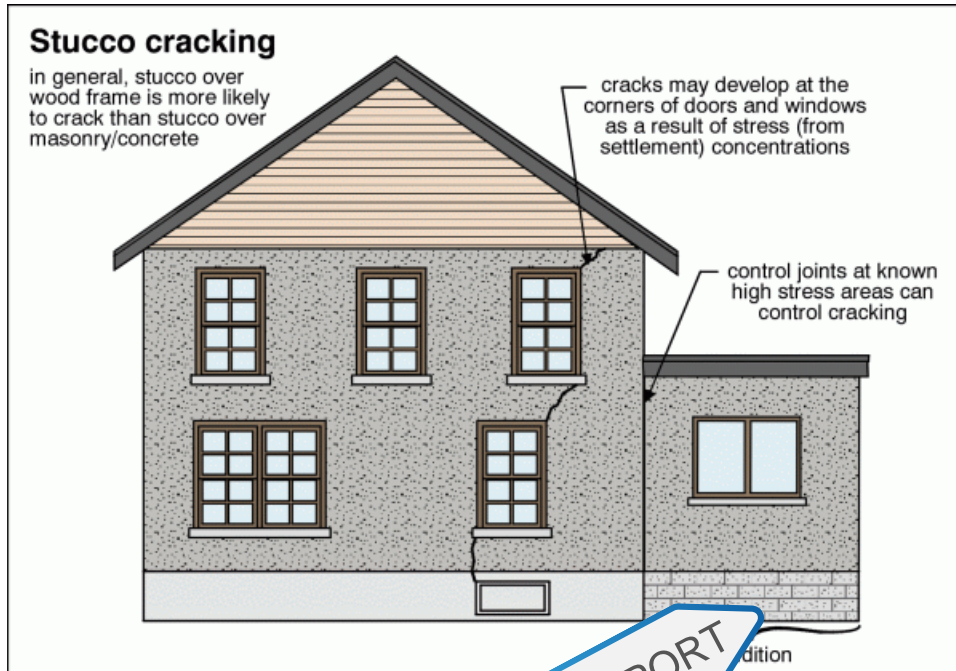
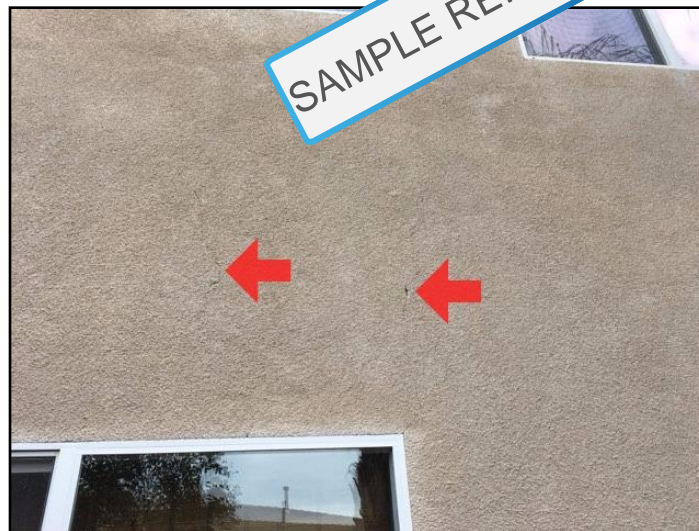
Condition: • [Cracked](#)

Implication(s): Material deterioration | Chance of water damage to contents, finishes and/or structure

Location: West exterior wall

Task: Seal cracks

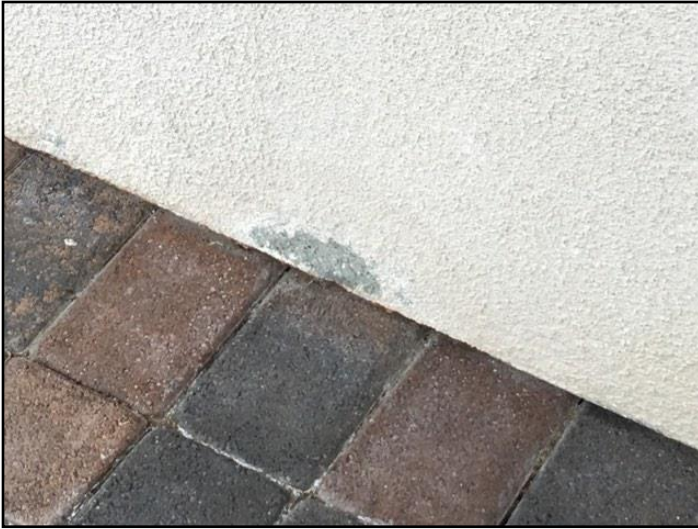
Condition: • [Crumbling](#)

Implication(s): Chance of water damage to contents, finishes and/or structure | Material deterioration

Location: Front of home, above garage, front porch, and southwest corner

*Stucco damage*

Task: Repair stucco

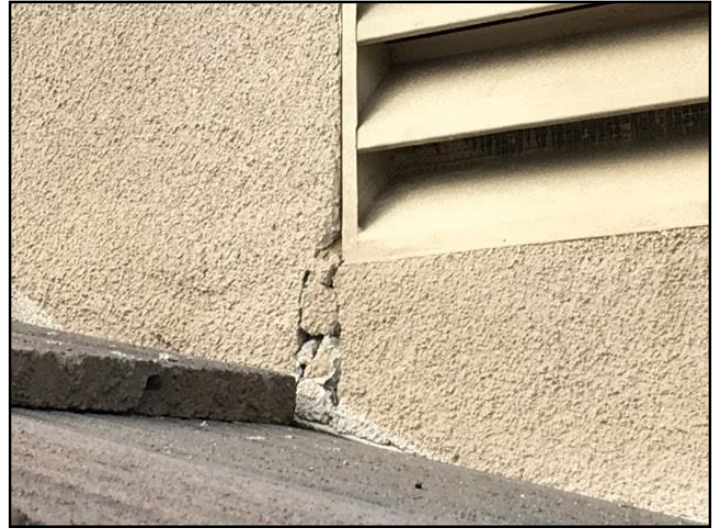
*Stucco damage*

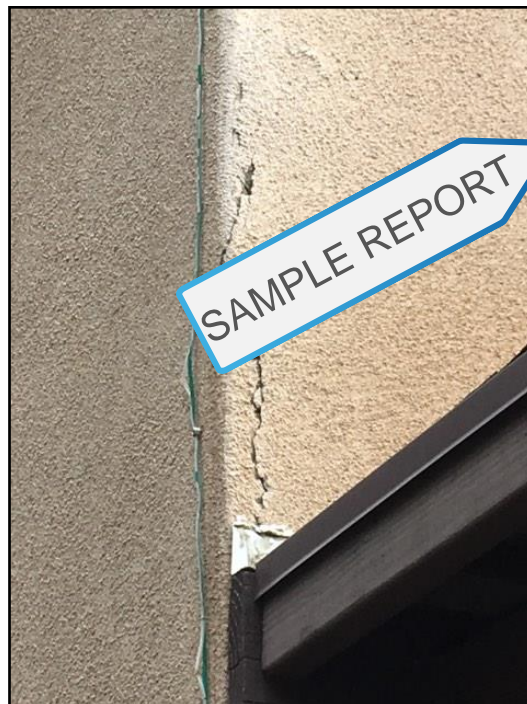
*Stucco damage***PORCHES, DECKS, STEPS, PATIOS AND BALCONIES \ General**

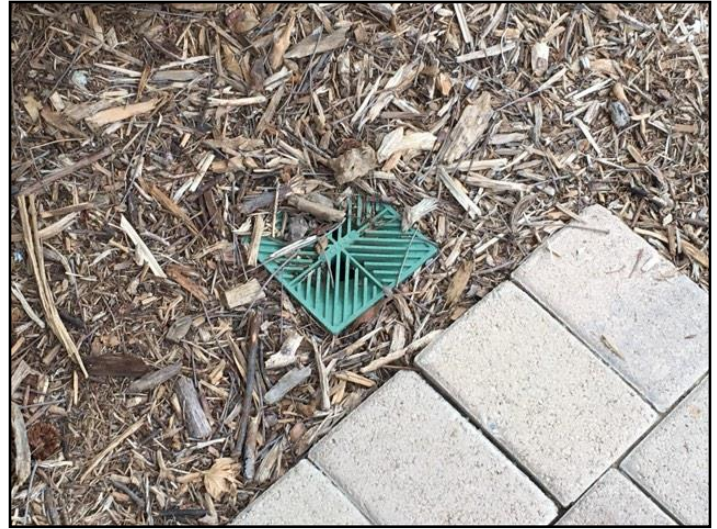
Note: Keep drain covers clear of debris

*Keep clear of debris***LANDSCAPING \ Driveway**

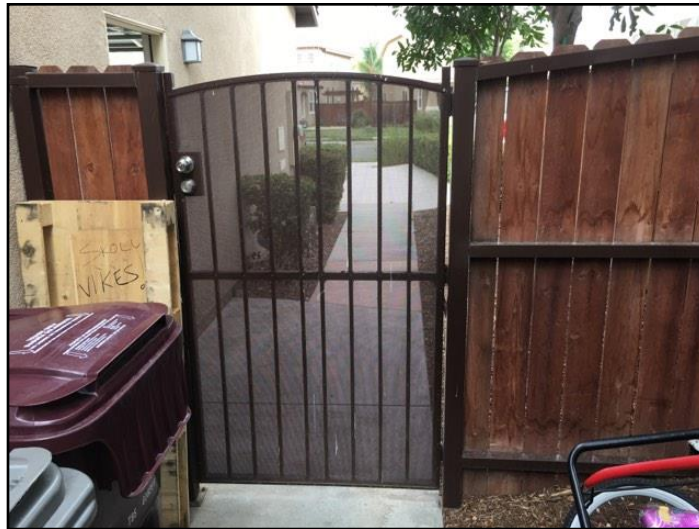
Condition: • Gate - adjustment needed

Implication(s): Reduced operability

Location: East gate

*Need adjustment***GARAGE \ General**

Task: Adjust to make square

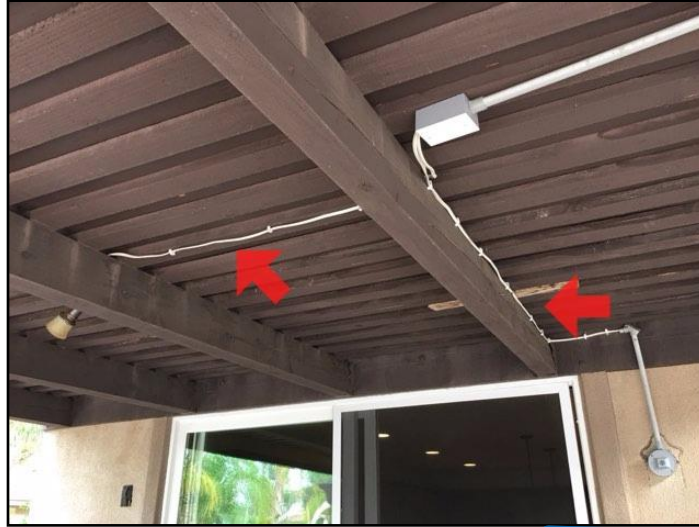
DISTRIBUTION SYSTEM \ Outdoor wiring**Condition:** • Exposed wiring**Implication(s):** Fire hazard**Location:** Rear patio**Task:** Enclose in conduit

*Exposed wires***DISTRIBUTION SYSTEM \ Outlets (receptacles)****Condition:** • [No GFCI \(Ground Fault Circuit Interrupter\)](#)**Implication(s):** Electric shock**Location:** Garage and laundry sink

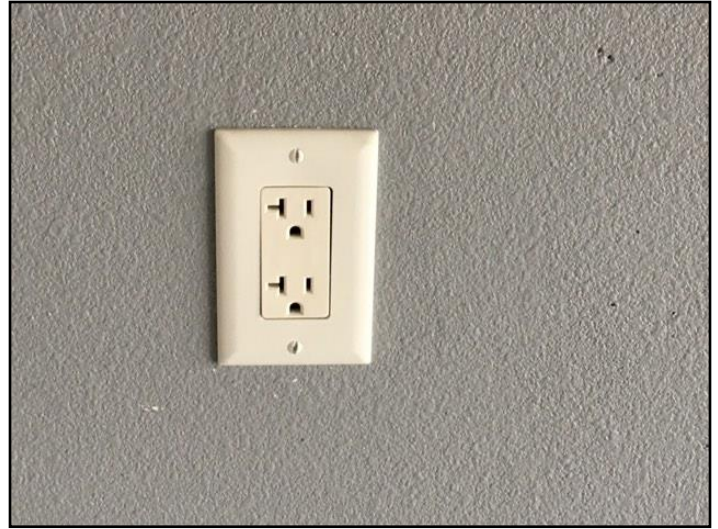
*Garage***DISTRIBUTION SYSTEM \ Smoke detectors**

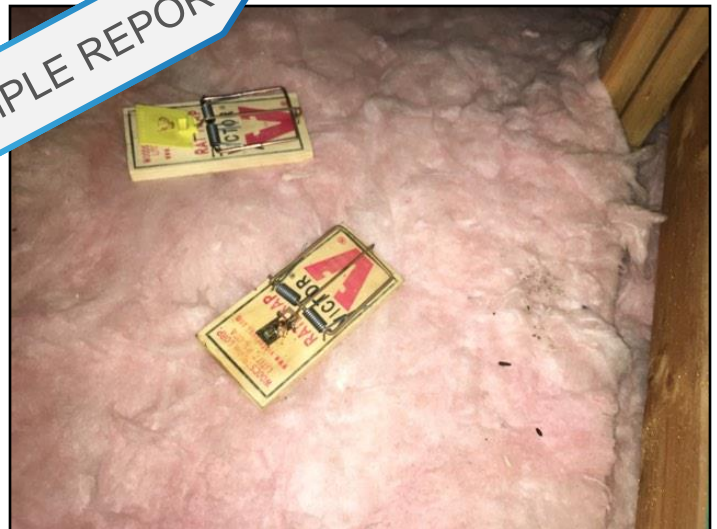
• Critter droppings were observed

Note: Multiple rodent traps were observed

Implication(s): Health hazard

Droppings and traps

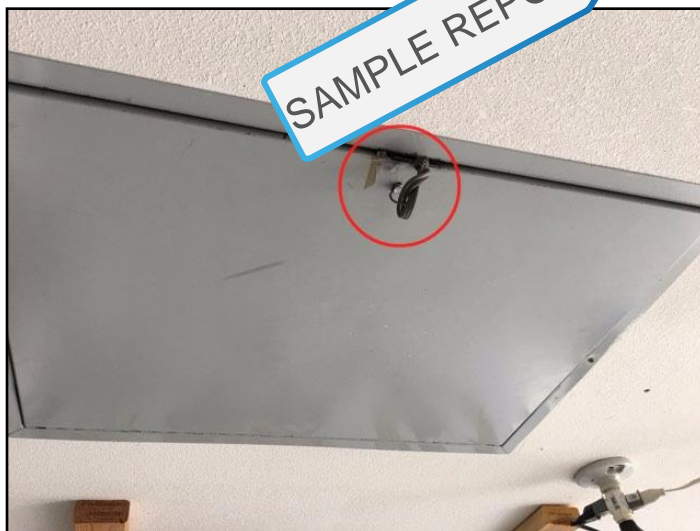
Condition: • Locking mechanism inoperable

Implication(s): Operation defect

Location: Garage

Inoperable mechanism

Task: Replace mechanism

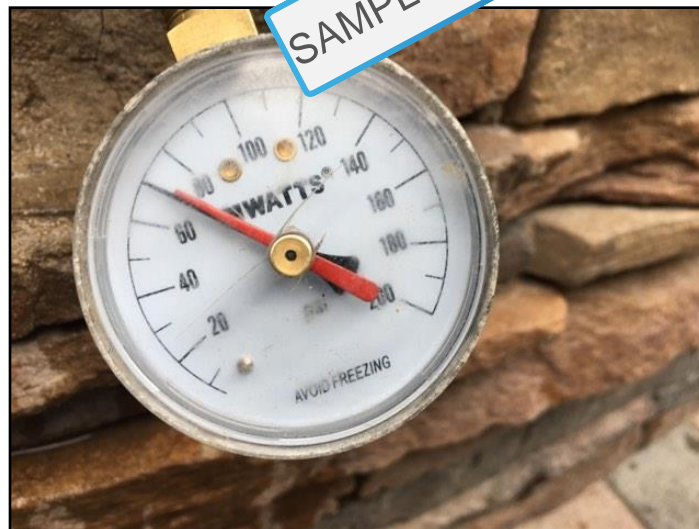
Condition: • The water pressure entering the home appears to be approximately 70 psi.

70 psi.

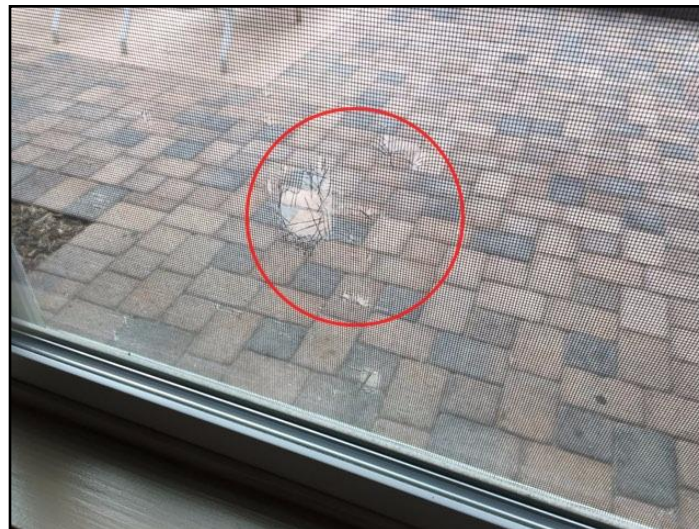
Condition: • [Torn](#)

Implication(s): Chance of pests entering building | Cosmetic defects

Location: Family room

Damaged screen

Task: Mend or replace

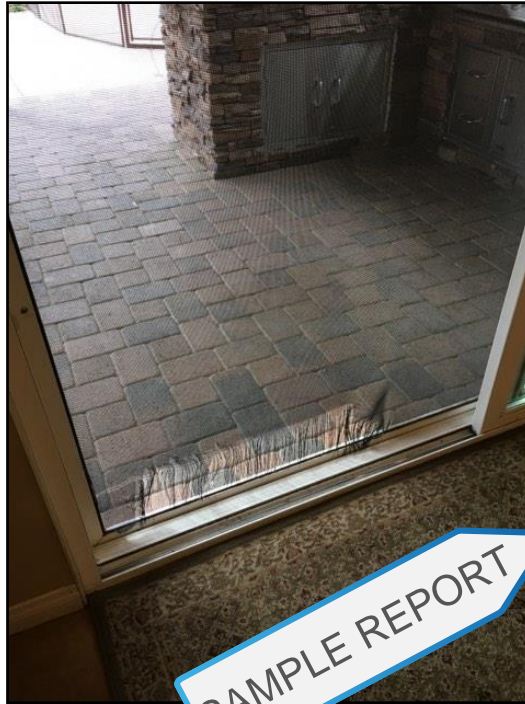
Condition: • [Torn](#)

Location: Rear slider

Damaged screen

Task: Replace screen

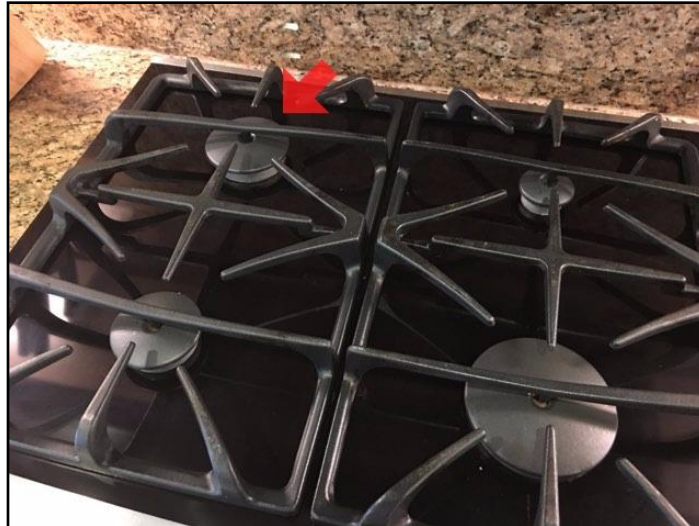
Condition: • Burner inoperative

Location: Top left burner

Not lighting

Task: Clean contacts

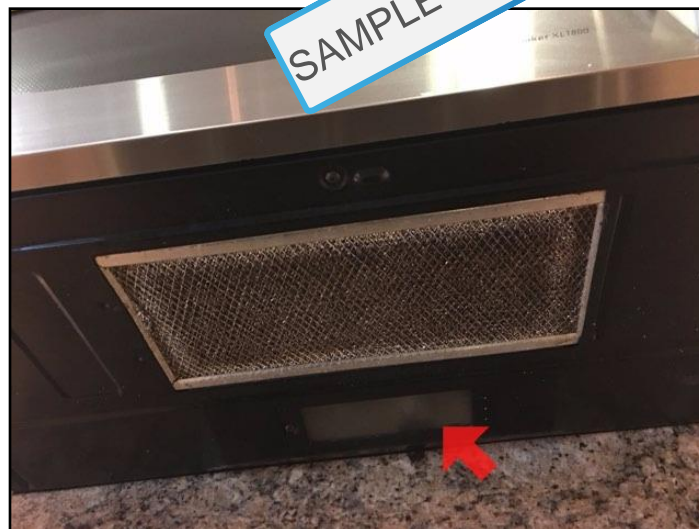
Condition: • Underneath light inoperable

Implication(s): Operation defect

Location: Kitchen

Task: Replace light source
