Your Inspection Report

SAMPLE REPORT

Friday, October 28, 2016

Terra Property Inspections - Johnny Carrillo

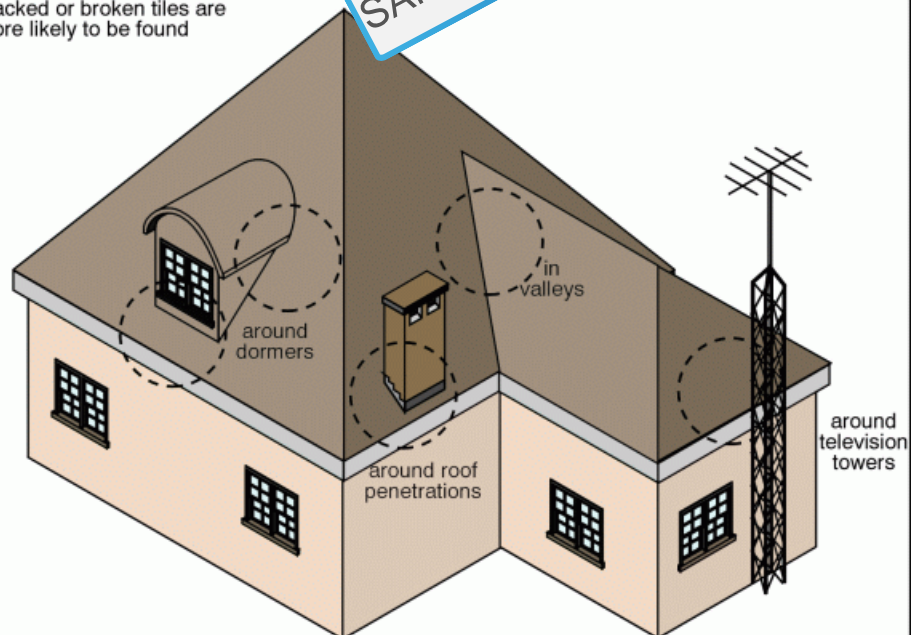
Cracked or broken tiles

the circled areas show where cracked or broken tiles are more likely to be found

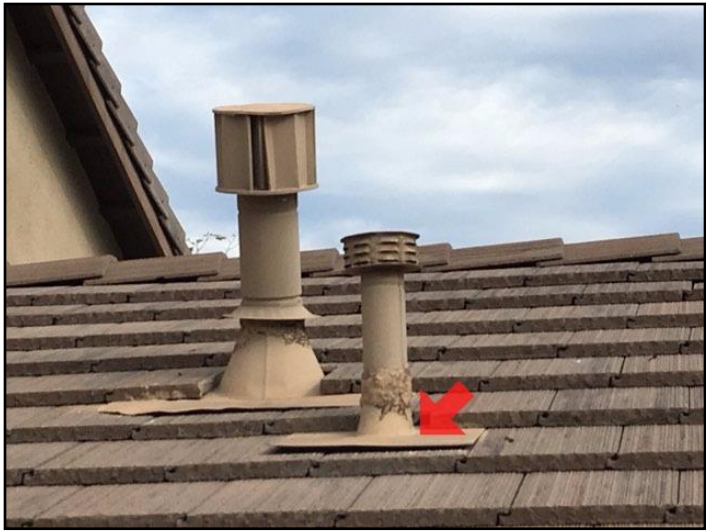
Properly flashed

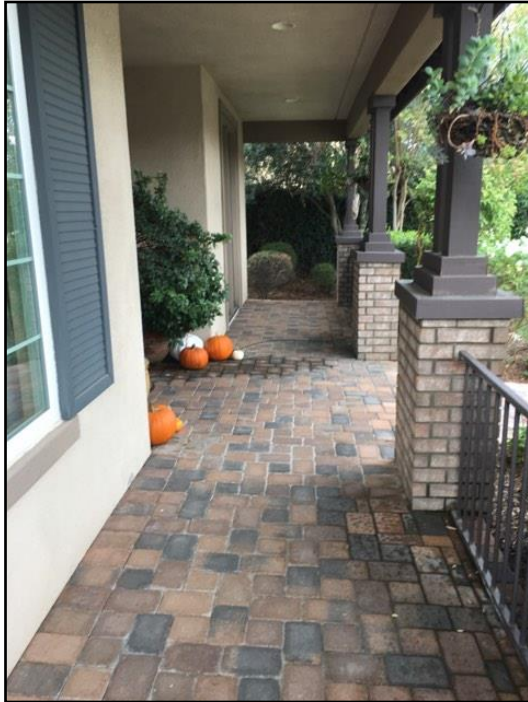
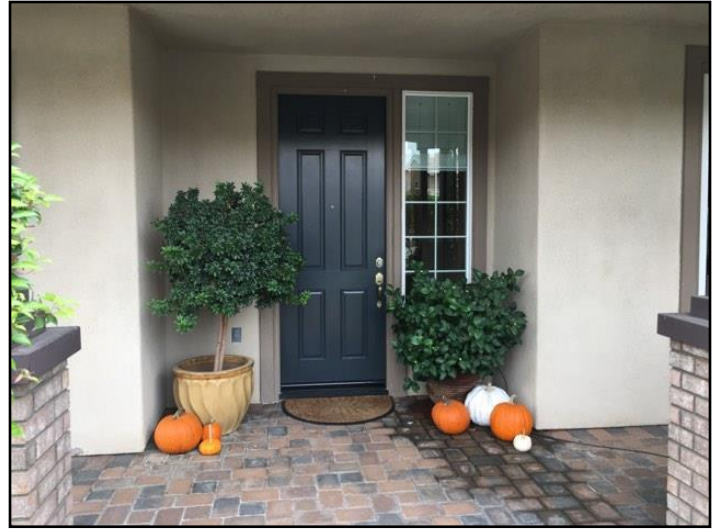
Front porch

Condition: • The porch(es) shows typical conditions related to the age of the home. Recommend monitoring for any developments.

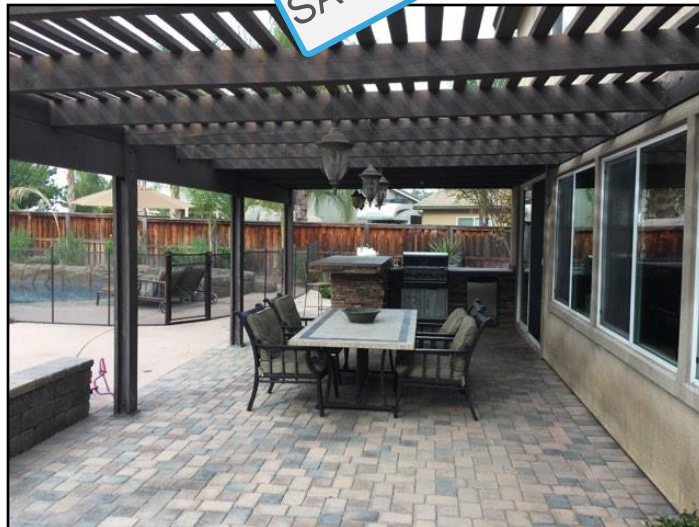
Rear patio

Condition: • The patio(s) show typical conditions related to the property. Recommend monitoring for any developments.

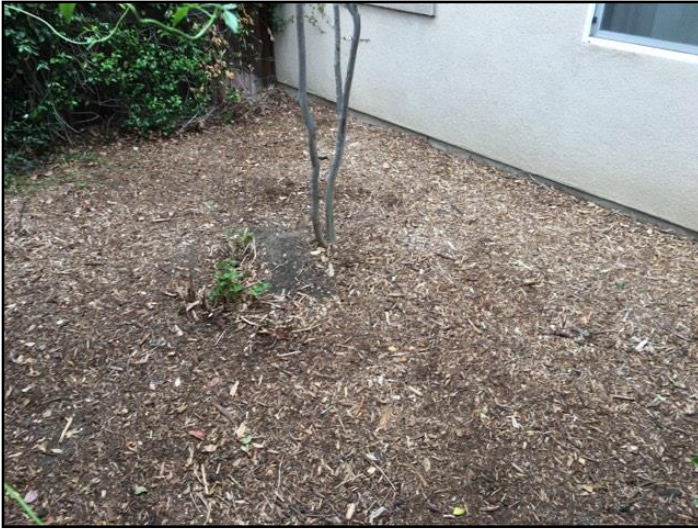
*View of landscape*

Condition: • There appears to be a proper slope away from the home, in the backyard, and sides of the home. Recommend monitoring for proper drainage throughout the property.

Note: Keep drain covers clear of debris

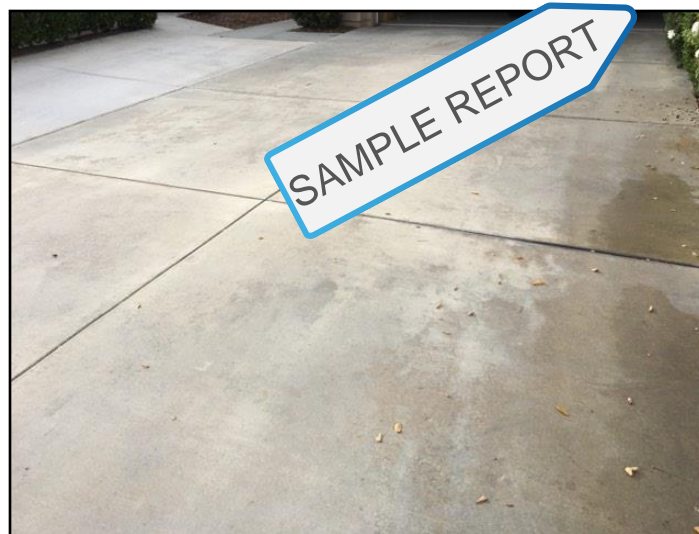
*Driveway***LANDSCAPING \ Walkway**

Condition: • The surface shows typical deteriorative conditions indicative to the age of the driveway. Recommend monitoring for any developments.

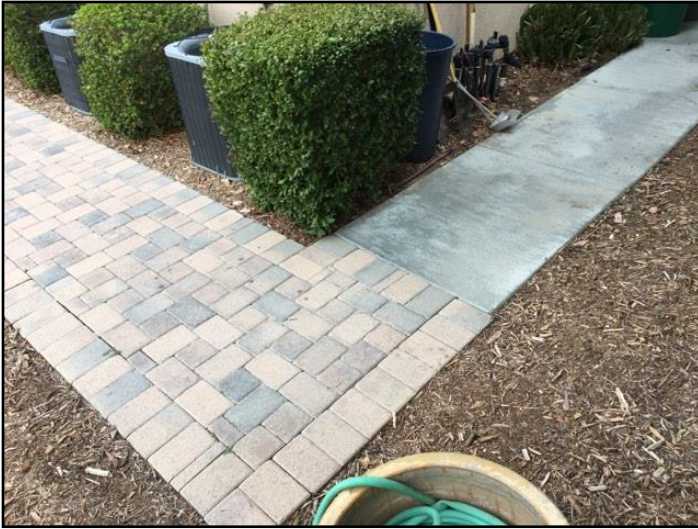
Rear walk

Condition: • Walks appear to show typical conditions related to the age of the property. Recommend monitoring for any developments.

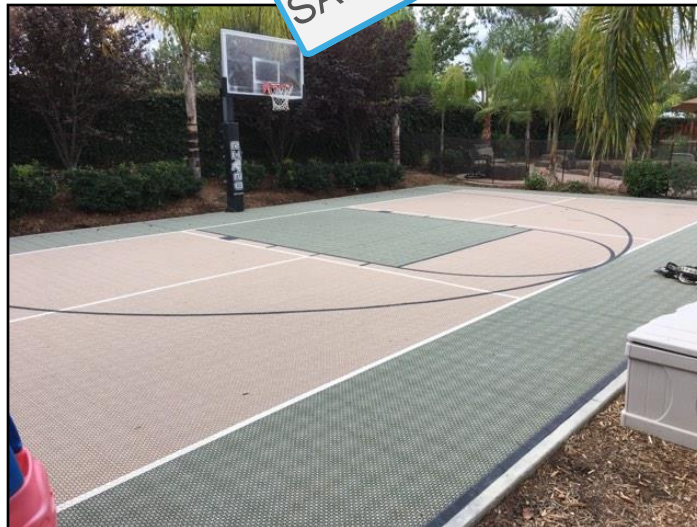
View of courtyard

Condition: • The courtyard shows typical conditions relative to the property. Recommend monitoring for any developments.

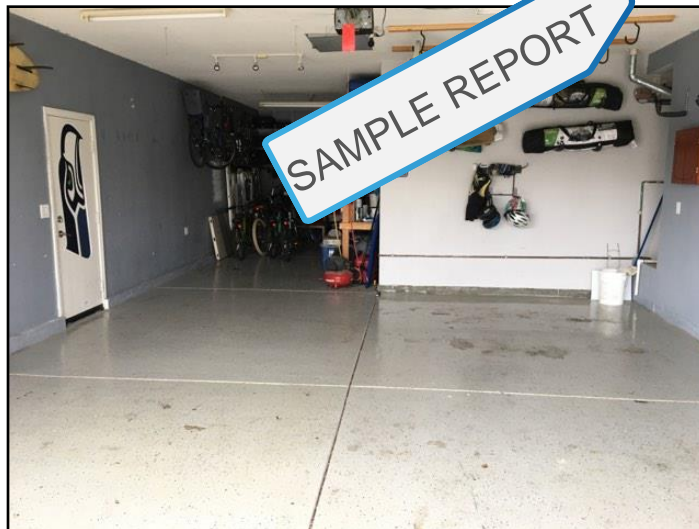
*Interior view***GARAGE \ Man-door into garage**

Condition: • The garage(s) appears to show typical conditions related to the age of the home. Please review the termite report.

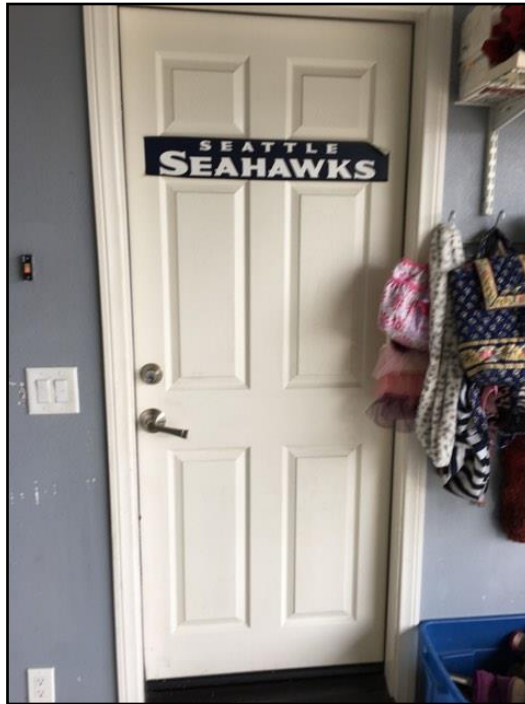
*Fire door***GARAGE \ Vehicle doors**

Condition: • The pedestrian door is fire-rated and self-closing. Recommend monitoring for any developments.

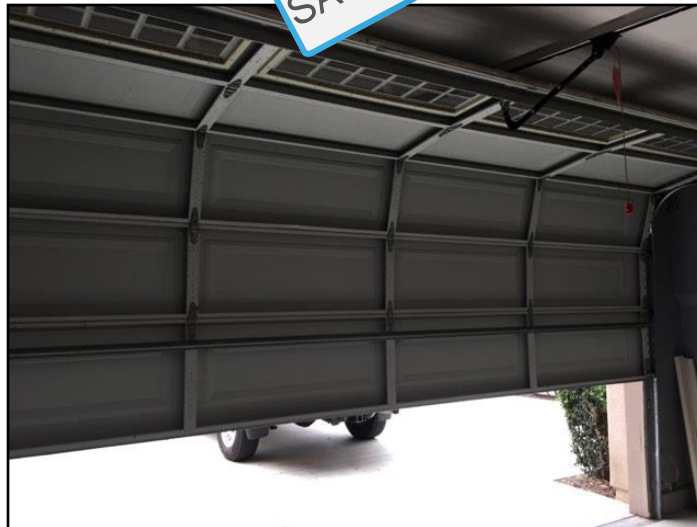
*Garage door***GARAGE \ Vehicle door operators**

Condition: • The garage door(s) appears to show typical wear and tear due to the age of the home. Recommend monitoring for any developments.

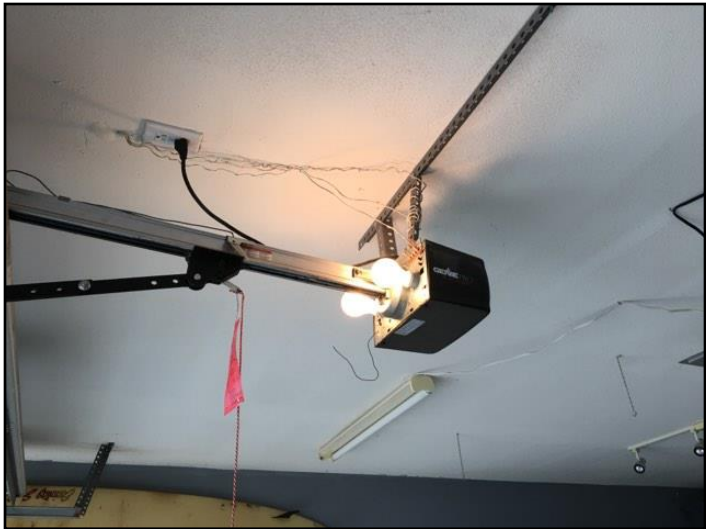
Opener

Condition: • The garage door opener(s) and electronic laser eyes are operable. Recommend monitoring for any developments.

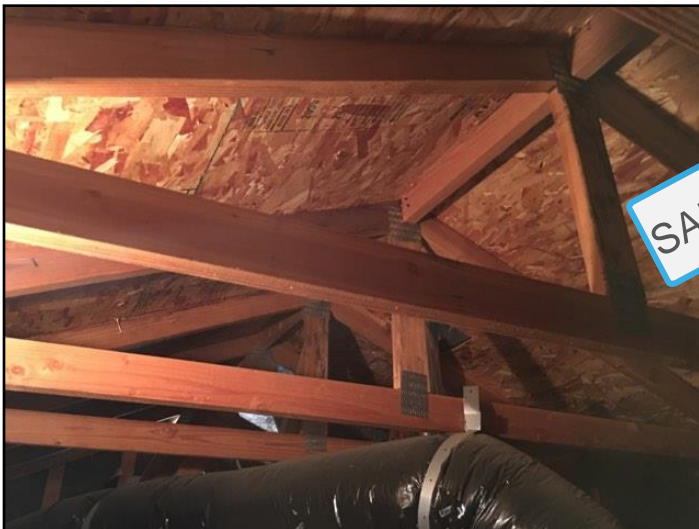
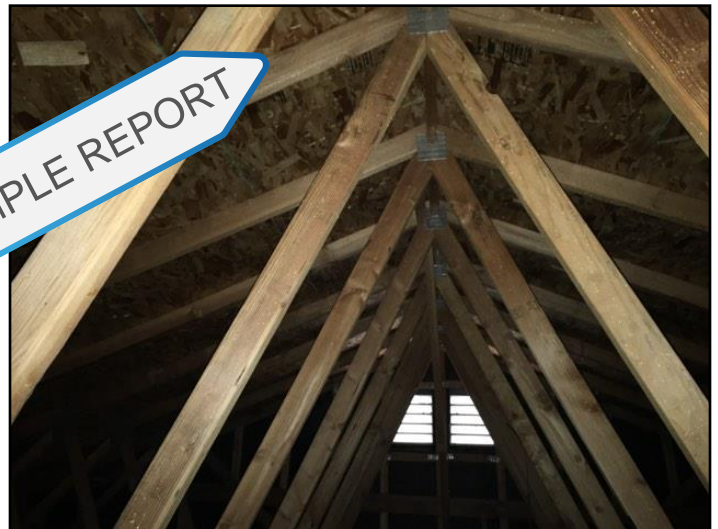
Framework

Condition: • The roof framing and support shows conditions indicative to the age of the home. Please review the termite report.

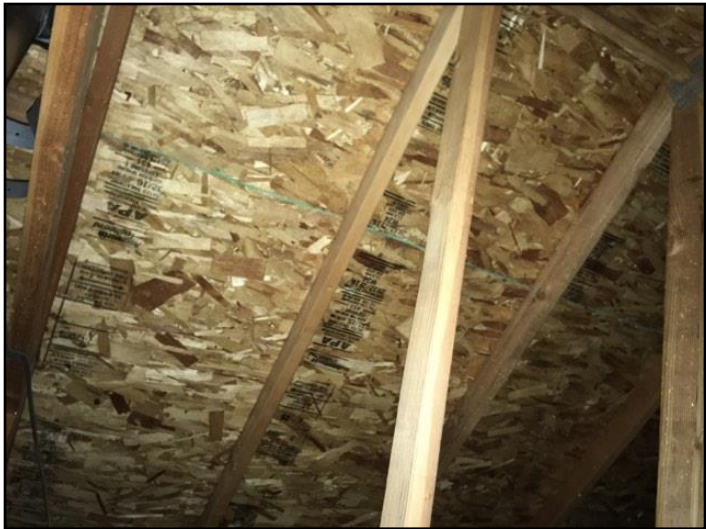
View of sheathing

Condition: • The roof sheathing appears to show typical condition related to the age of the home. Please review the termite report.

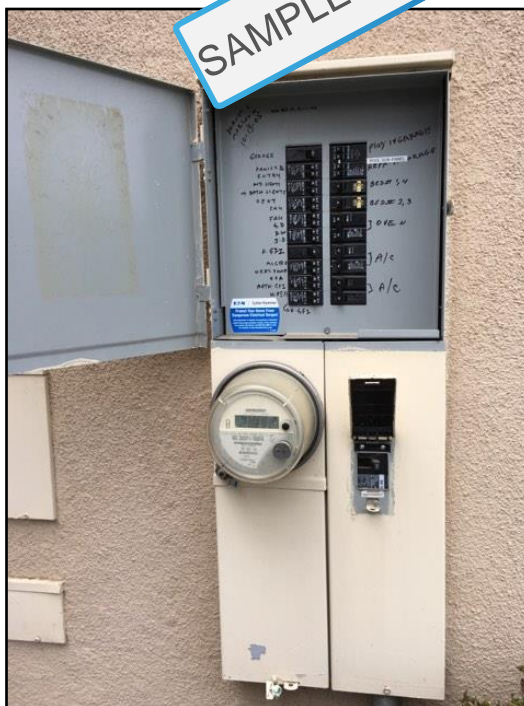
Panel and meter

Condition: • All systems and components to the main electrical service are to be satisfactory. Recommend monitoring for any possible developments.

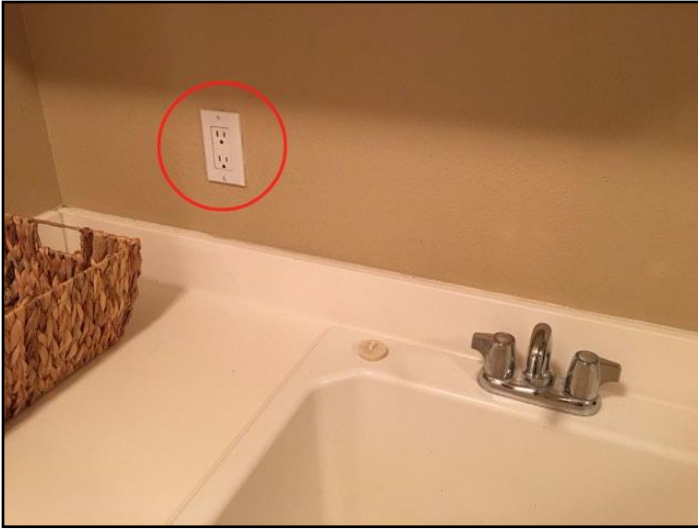
*Laundry sink*

*Exposed wires***DISTRIBUTION SYSTEM \ Outlets (receptacles)****Condition:** • [No GFCI \(Ground Fault Circuit Interrupter\)](#)**Implication(s):** Electric shock**Location:** Garage and laundry sink

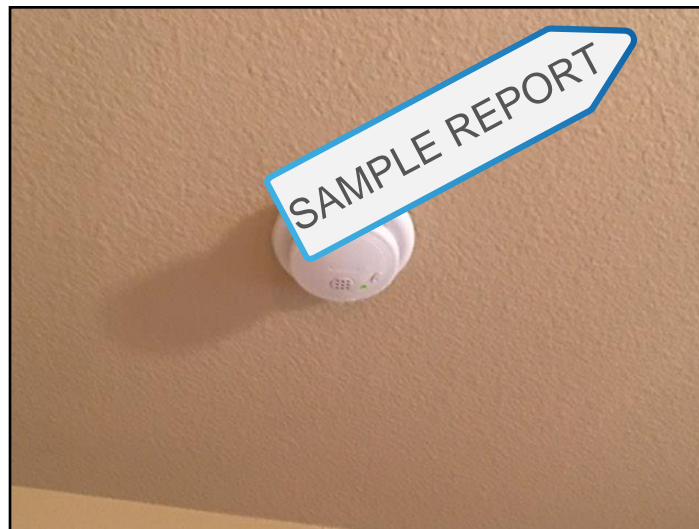
*Smoke detector***DISTRIBUTION SYSTEM \ Carbon monoxide (CO) detectors**

Condition: • Smoke detectors are present and properly located. Recommend confirming detectors be supplied with fresh batteries at all times.

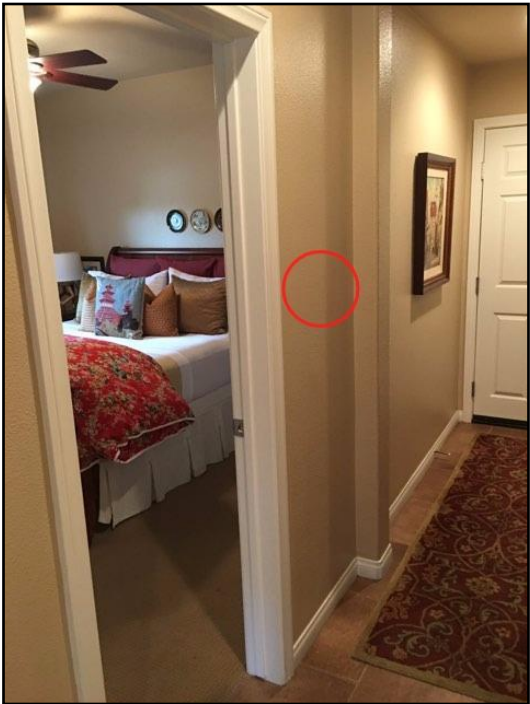
Condition: • Missing

Implication(s): Health hazard

Need al detector

Task: Install CO detector

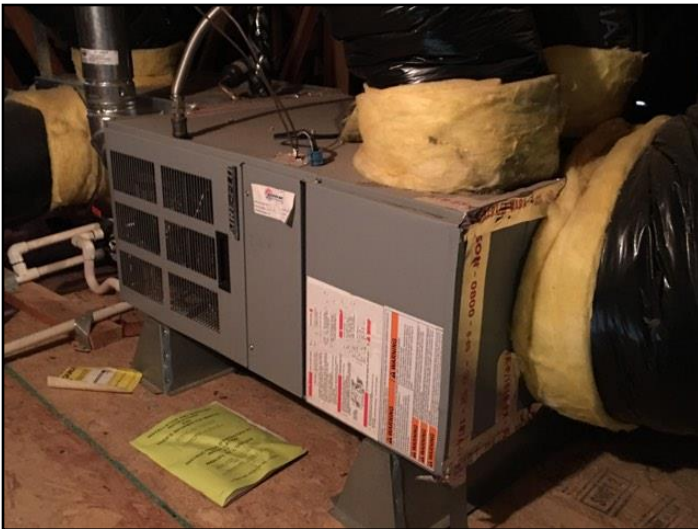
Downstairs furnace

Condition: • The operation of the furnace(s) appears to be satisfactory at the time of the inspection. Recommend monitoring for any developments.

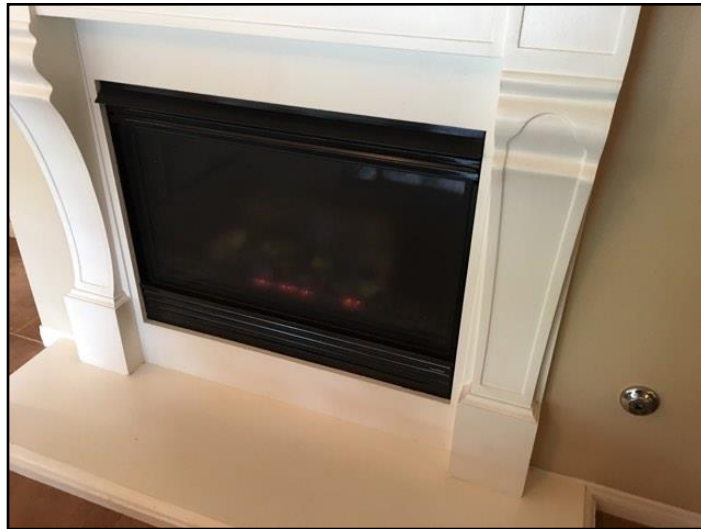
Fireplace

Condition: • The fireplace shows typical conditions related to the age the home. Recommend monitoring for any

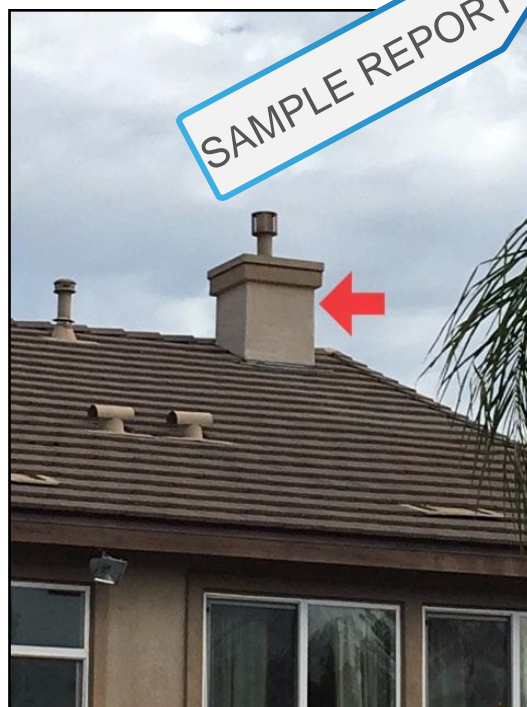
Chimney

Condition: • The chimney shows typical condition related to the age of the home. Recommend monitoring for any developments.

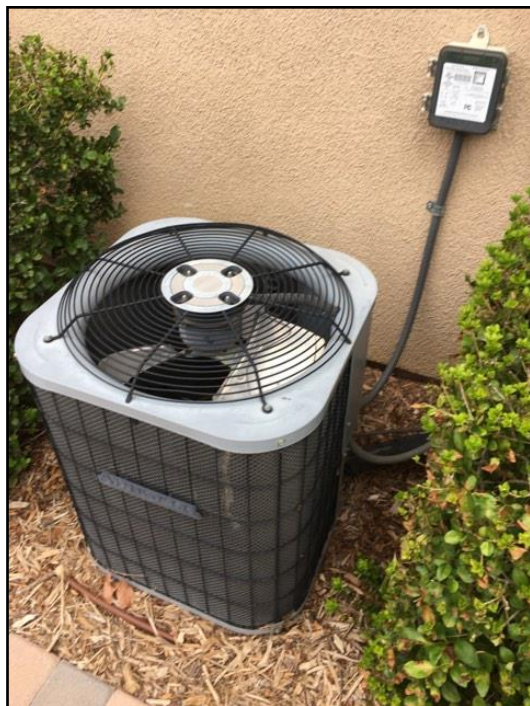
Upstairs A/C unit

Condition: • The operation, condition and installation of the A/C unit appears to be satisfactory. Recommend monitoring for any developments.

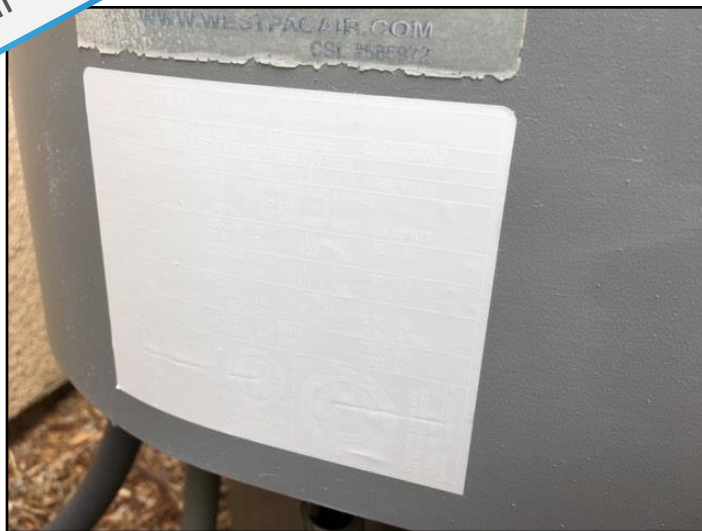
General: • The manufacturers' label is missing or faded. Could not confirm model, serial#, capacity and exact age of A/C unit.

Faded label

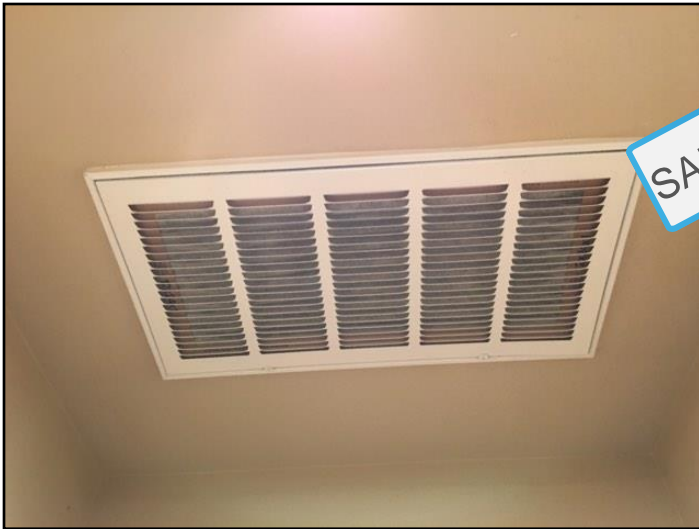
Downstairs air filter

Condition: • The air filter(s) appear to be satisfactory at the time of the inspection. Recommend replacing at least twice a year

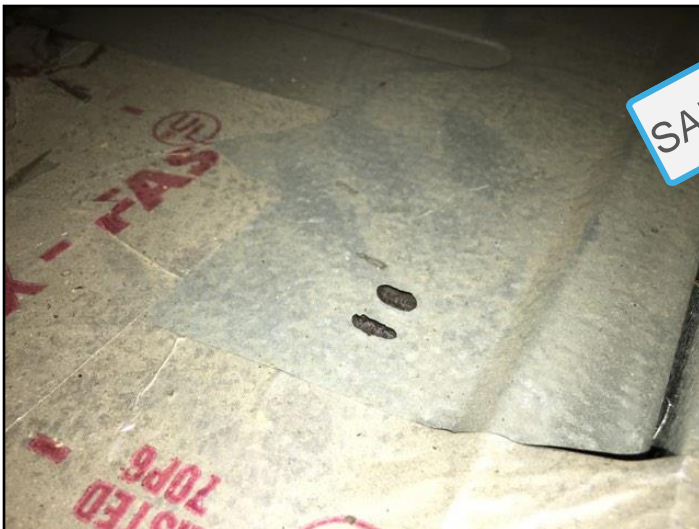
• Critter droppings were observed

Note: Multiple rodent traps were observed

Implication(s): Health hazard

Location: Attic and above garage

Droppings

Task: Contact licensed pest control company

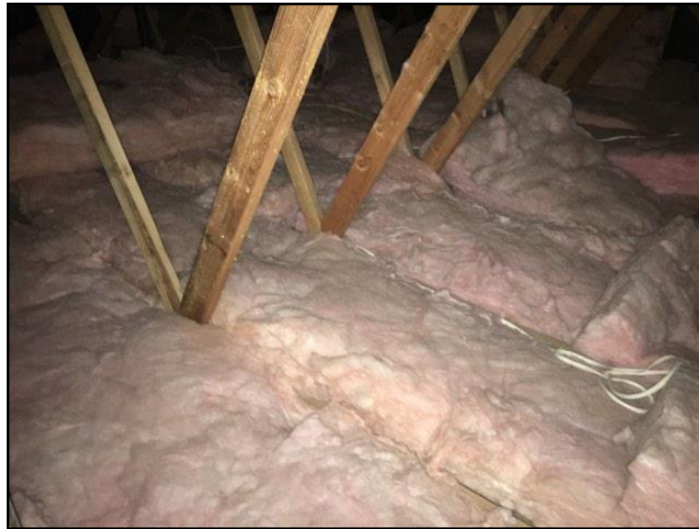
Insulation

Condition: • The insulation appears to be sufficient. Recommend monitoring for any developments.

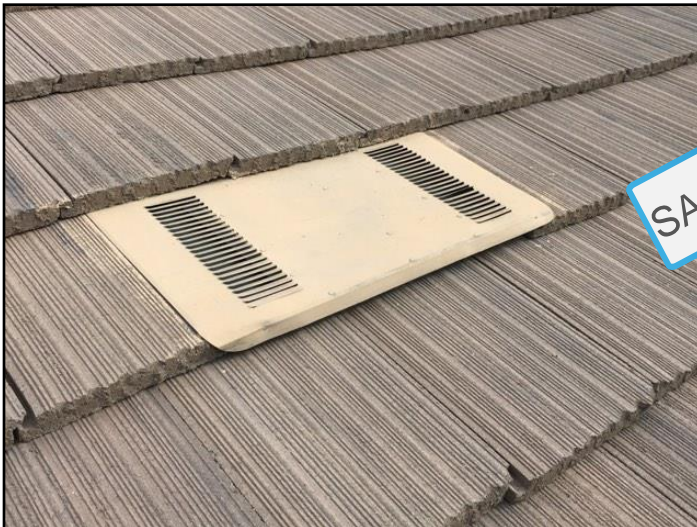
Roof

Condition: • Attic ventilation appears to be adequate. Recommend monitoring for any possible developments.

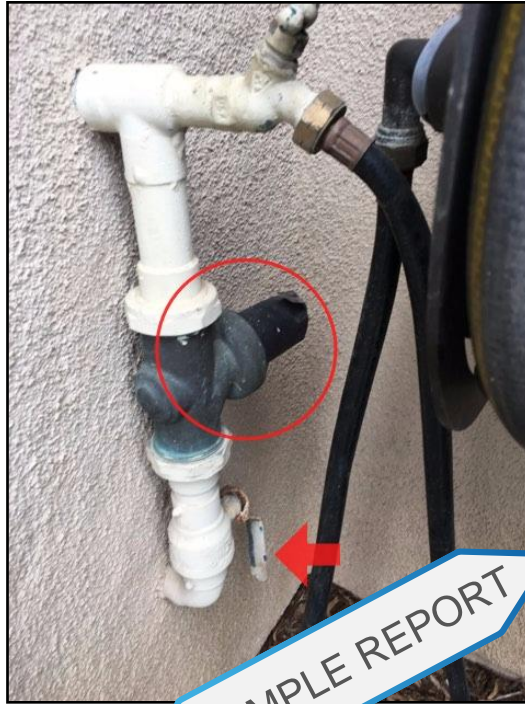
Shut off lever and gas regulator

Condition: • All components related to the main plumbing system appear to be satisfactory. Recommend monitoring for any possible developments.

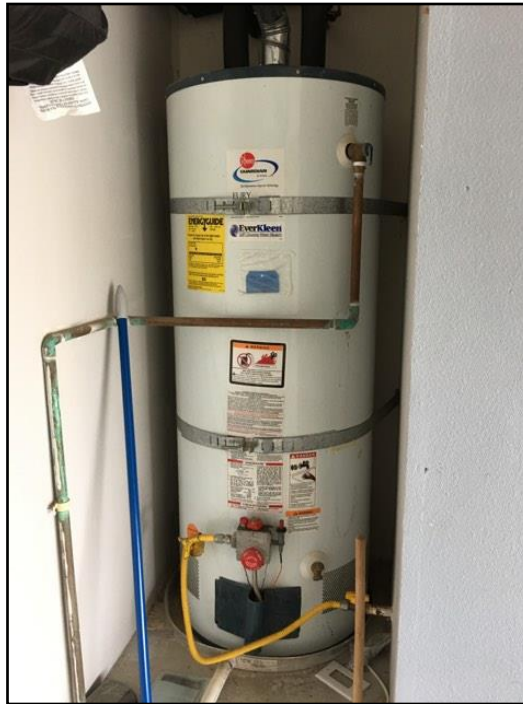
Water heater

Condition: • The operation and installation of the water heater(s) appears to be satisfactory. Recommend monitoring for any developments.

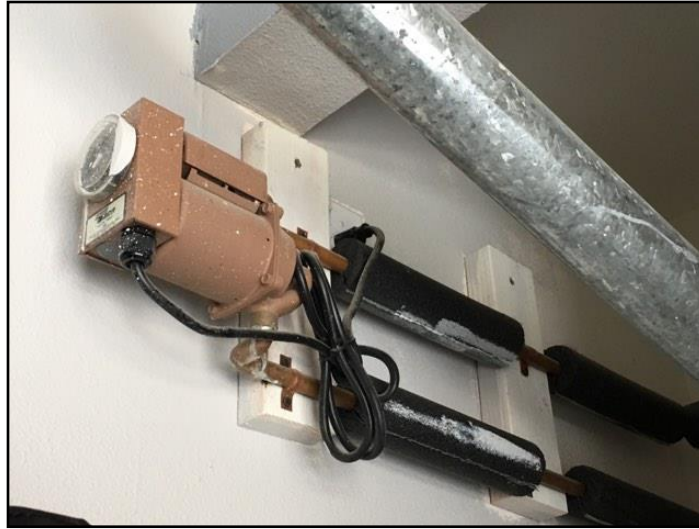
Circulating pump

Condition: • View of pump - Operation not confirmed

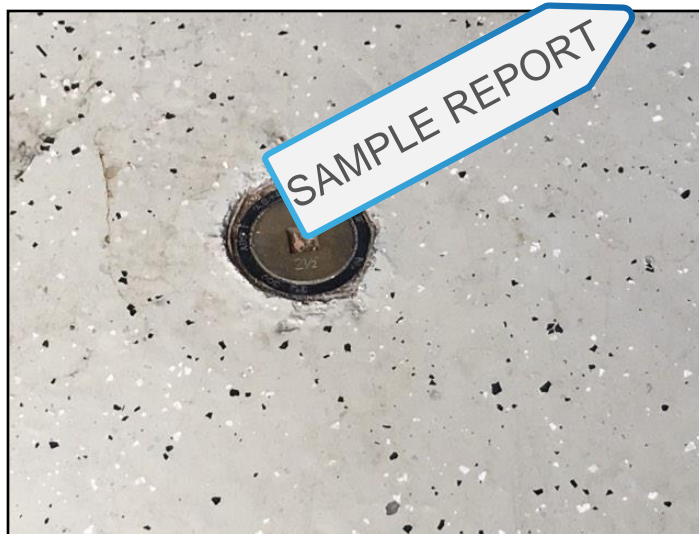
Clean-out

Condition: • View of clean-out access

Location: Garage

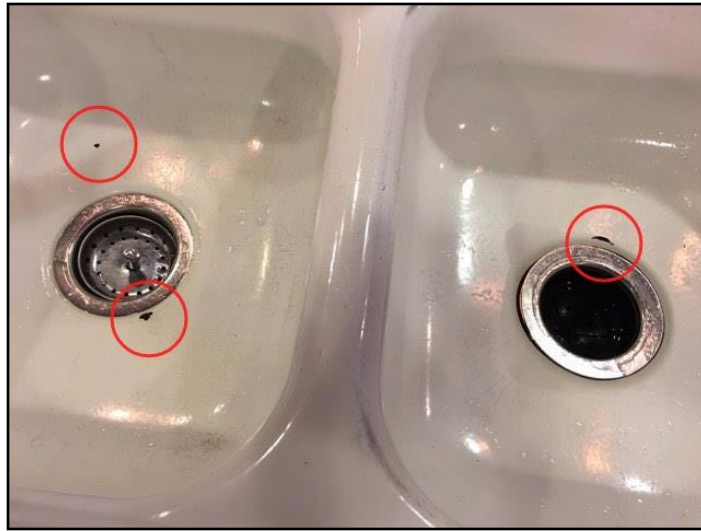
Condition: • [Surface defects](#)

Implication(s): Hygiene issue | Cosmetic defects

Location: Kitchen sink

Surface chips

Task: Apply porcelain epoxy

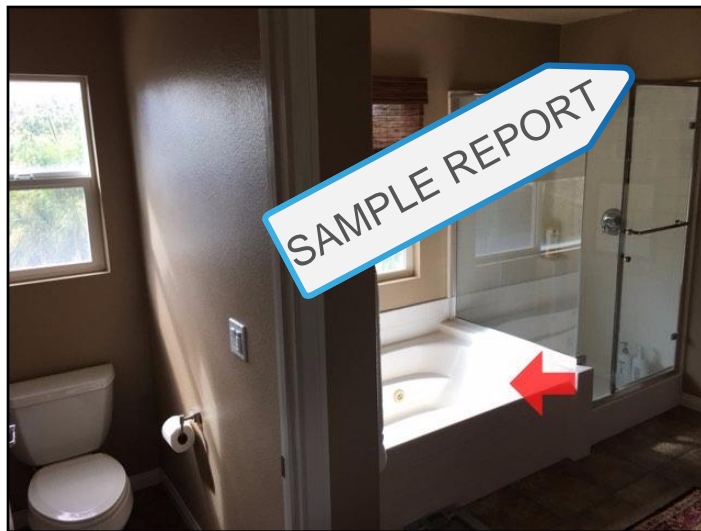
Jetted tub

Condition: • The operation of the jets appear to be satisfactory. Recommend monitoring for any developments.

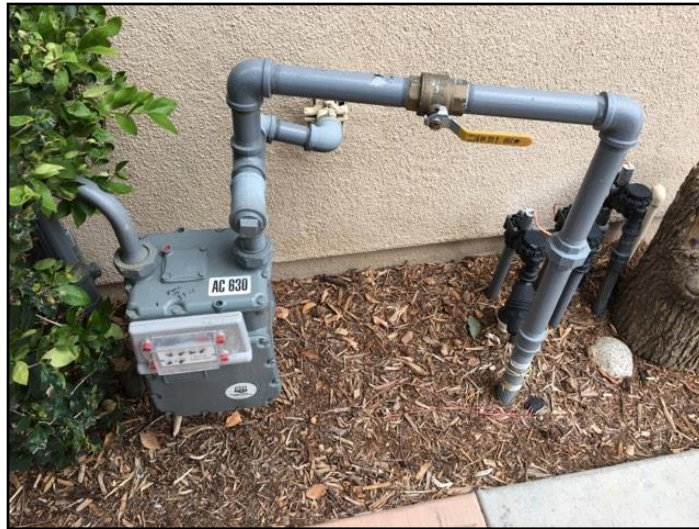
Gas meter

Condition: • The gas meter and exposed supply lines appears to be in satisfactory condition. Recommend monitoring for any possible developments.

Note: Recommend placing a gas wrench or any other type of wrench at the gas meter. In case of an emergency, a quick shut off to the gas supply is essential.

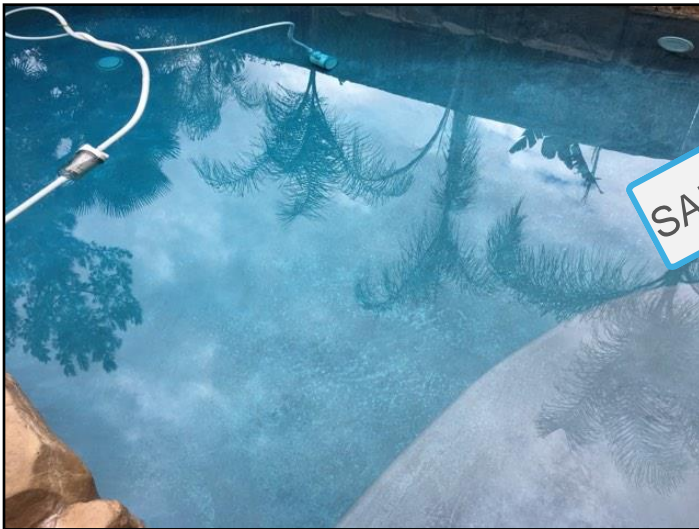
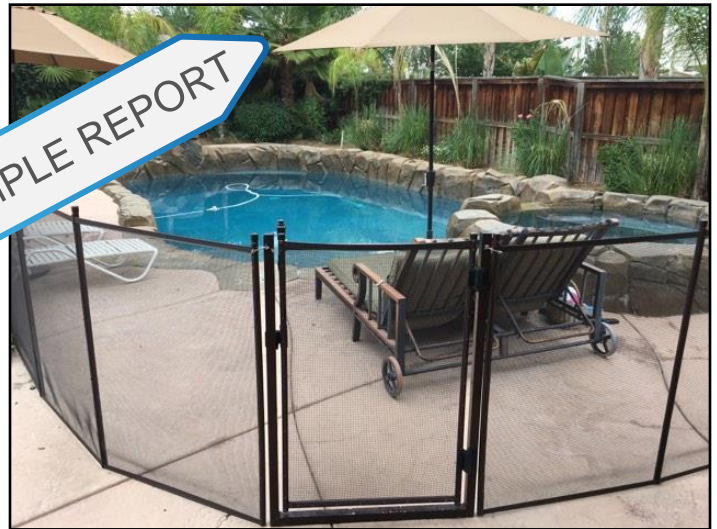
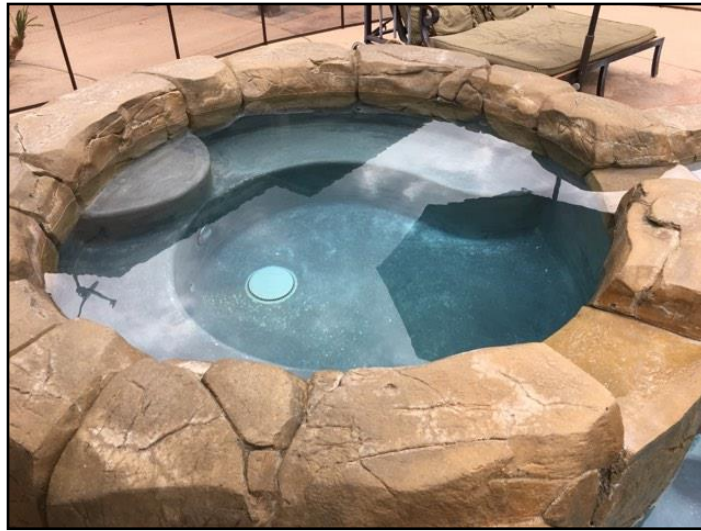
Condition: • All pool/spa surfaces appear to be satisfactory. Recommend monitoring for any developments.

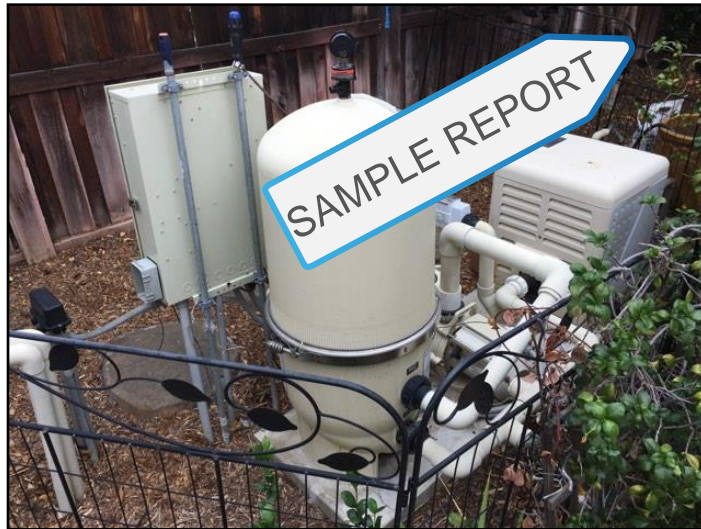
View of pool equipment

Condition: • All related equipment appears to be satisfactory. Recommend monitoring for any developments.

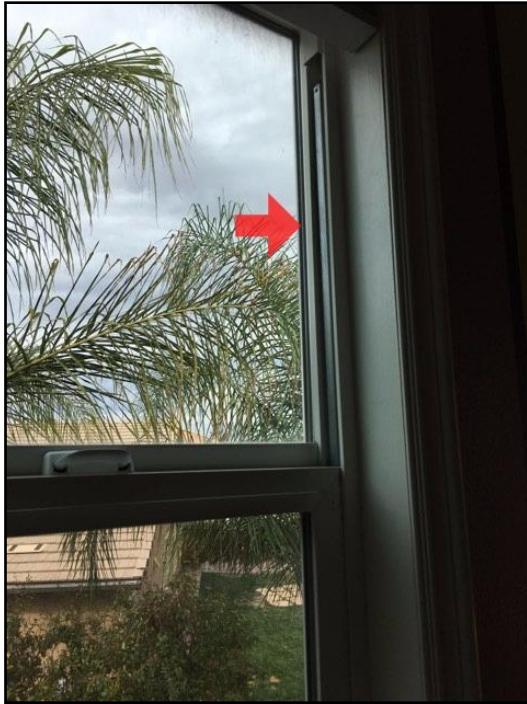
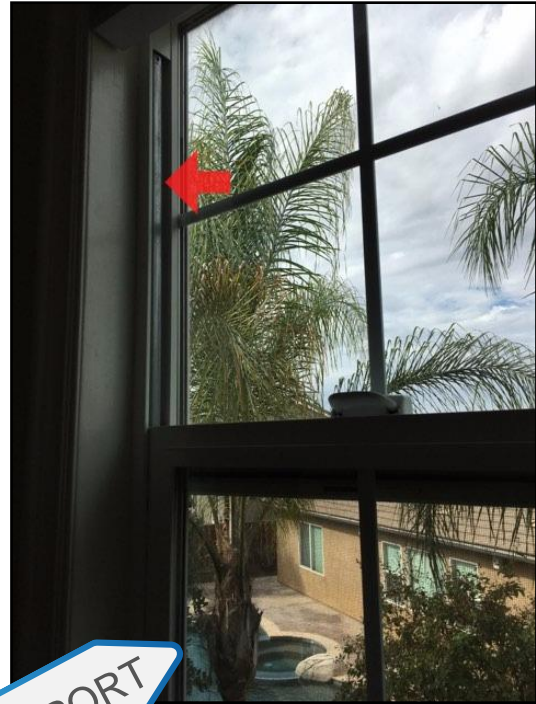
Condition: • Detached balance(s)

Implication(s): Operation defect

Location: Front west bedroom

Detached

Task: Re-attach balances

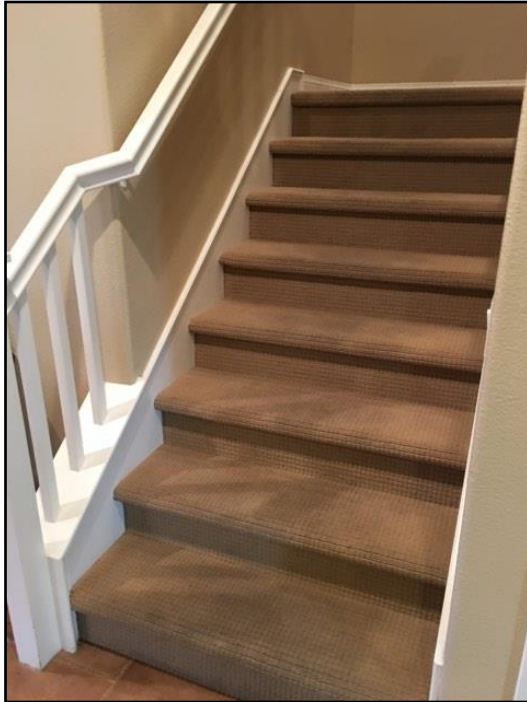
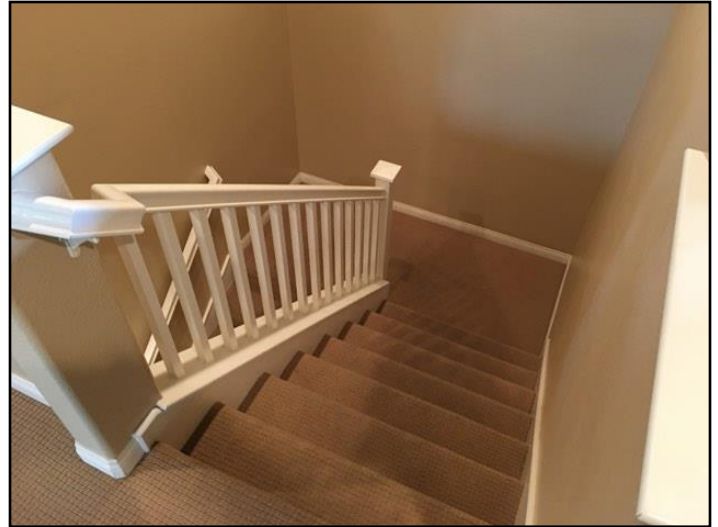
Condition: • The stairs/railing and related components appear to show conditions indicative to the age of the home. Recommend monitoring for any developments.

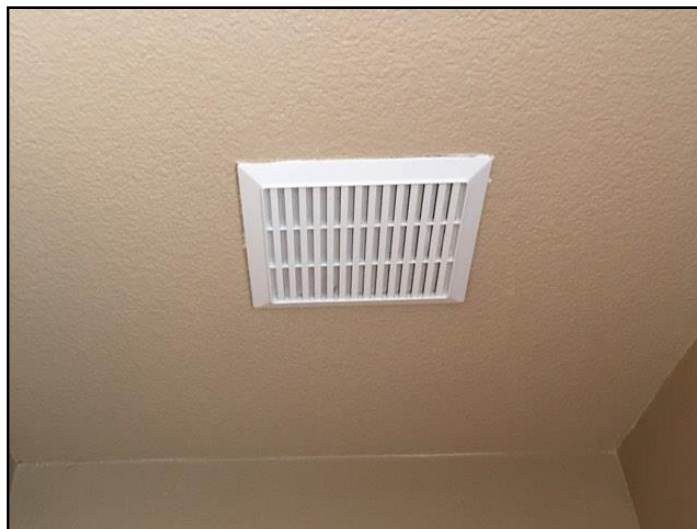
Condition: • [Noisy](#)

Implication(s): Reduced system life expectancy | Equipment failure

Noisy fan

Task: Closely monitor
